Effect of biochemical environment on fiber concrete containing silica fume

Ourdia Fedaoui-Akmoussi, Salah Kaci, Raoul Jauberthie, Laurent Molez

Ourdia Fedaoui-Akmoussi, Salah Kaci, Raoul Jauberthie, Laurent Molez. Effect of biochemical environment on fiber concrete containing silica fume. *Chemistry and Materials Research*, 2013, 5, pp.48-52. hal-01005521

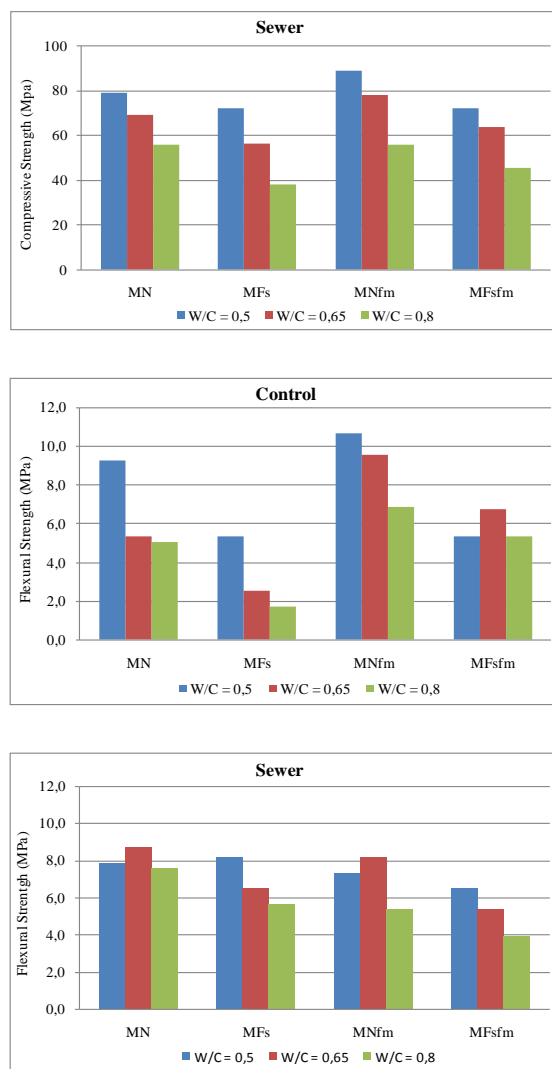
The stress at failure was determined in flexure and compression for the various water cement ratios. Fig 1 show the results obtained for mortars conserved in the two environments (pumping station sump and cyclic wetting / drying).

Fig. 1. Variation in compressive and flexural strength.

With regard to the compressive strengths: The mortar with fibres (MNfm, MFsfm) showed slightly higher strengths, when compared with the same mortars without fibres (MN, MFs), for both exposure environments and for all water cement ratios.

In the case of the control samples, exposed to wetting and drying under laboratory conditions, the samples with fibres (MFsfm) showed a higher flexural strength than the control samples without fibres (MFs). On the other hand the flexural strength of the MNfm and MFsfm mortars was lower than the MN and MFs mortar when exposed to sewage. These samples have been exposed to aggressive agents in the sewer; the steel fibres have corroded and suffer a loss in section and consequently a reduction in strength and bond; this also resulted in an increase in porosity and surface cracking with a consequential reduction in flexural strength. On the basis of these observations it is noted that the use of steel fibres in a wastewater environment may have a detrimental effect on performance except if the fibres are well coated.

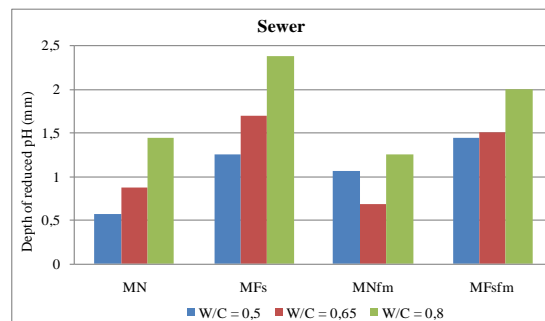
The depth of pH modification of the mortar was determined by the phenolphthalein test (color indicator); a sprayed solution turns pink if the pH is greater than 9 which allow the visualization of the modification to the mortar. Five measurements were taken from each face of the sample, ignoring the measurements at the corners; this allowed a mean value of 20 readings for each sample. Figure 2 sets out the average depth of pH reduction.

Fig. 2. Variations in depth of pH change for exposure samples.

It is interesting to note the variation of depth of pH reduction for the three water cement ratios: For a water cement ratio of 0.5 the steel fibres mortar had a greater depth of pH loss whereas with the higher w/c ratios the converse was true. This can be explained by two factors being responsible for the alteration of pH. Firstly, as previously noted the corrosion of the steel fibres engenders an opening of the structure; secondly as the w/c ratio increases the cement paste becomes more porous.

Given a low w/c ratio the C-S-H resulting from the pozzolanic action of Portlandite and silica fume will fill pores in the matrix. In cases where the matrix has an initial high volume of voids, higher w/c ratios, the secondary C-S-H is insufficient to block the pore structure. In the cases of high w/c ratios (0.65 and 0.8) the high porosity of the cement paste has a dominant effect with respect to depth of pH reduction, i.e. steel fibre corrosion occurs but the subsequent effect is secondary to the cement paste porosity.

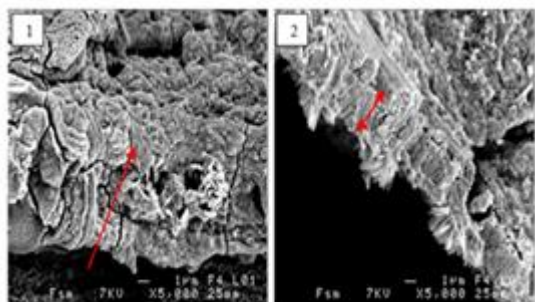
Fig. 3. Aspect of Surface degradation.

On photograph 1, we can see the dried organic material which gives this aspect of wrinkling. The aspect of C-S-H degraded on the surface of sample is shown in photo 2. We can notice that the degradation of C-S-H was apparent on a small thickness of about 4 microns.

Observations by scanning electron microscope (SEM) are shown in Figure 3 and 4; these observations were restricted to the MFsfm samples, w/c ratio 0.8, conserved in the sewer. The aim of this exercise was to study a series which had undergone the most marked modification to microstructure.

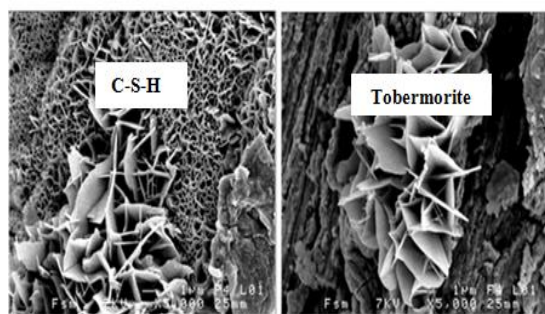
Fig. 4. Healthy phase of the concrete (C-S-H).

Fig 4 shows the phase of sound concrete. The photos shows the undegraded plates of C-H-S which one also calls "Tobermorite".
